PRELIMINARY NONDESTRUCTIVE EVALUATION MANUAL FOR THE SPACE SHUTTLE

**PRELIMINARY NONDESTRUCTIVE EVALUATION MANUAL
FOR THE SPACE SHUTTLE**

APPENDIX TO FINAL REPORT

**LOCKHEED-GEORGIA COMPANY
A DIVISION OF LOCKHEED AIRCRAFT CORPORATION
MARIETTA, GEORGIA 30063**

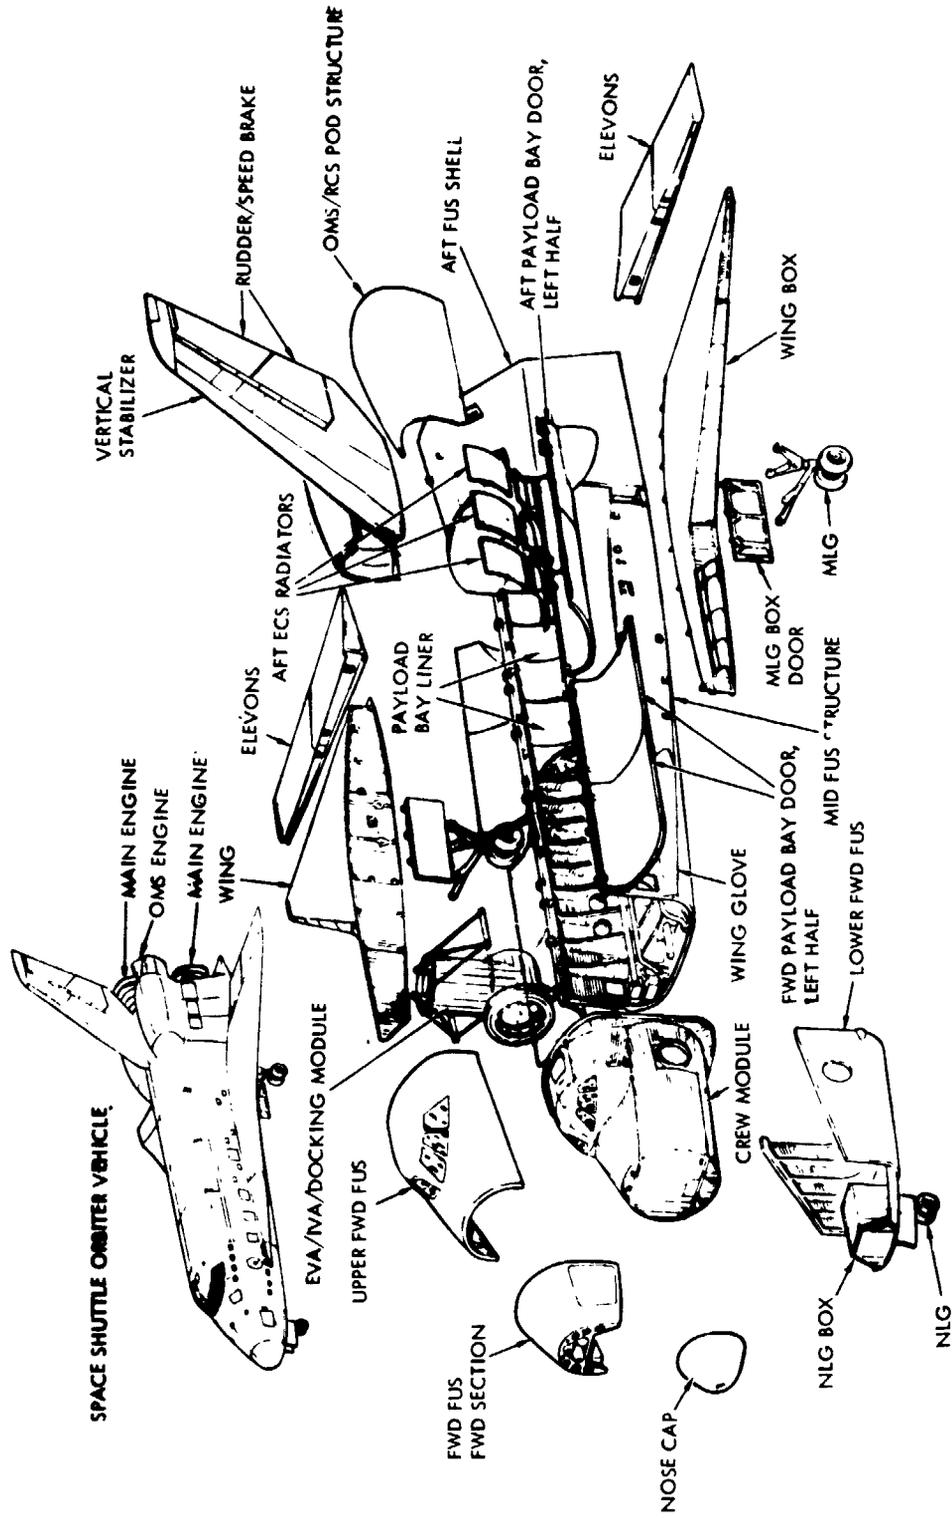
Figure 1-2. Major Subassembly Breakdown Diagram for Orbiter

The forward fuselage structure extends from $X_{\circ} 238$ to $X_{\circ} 576$ and contains the fwd fuselage shell, crew module, nose landing gear, and the nose section. The nose section accommodates the NLG and RCS module. The $X_{\circ} 378$ bulkhead, which is the nose section aft boundary, has interface fittings for the NLG, the RCS module, and ET forward attach point and hoisting/jacking provisions. The $X_{\circ} 378$ bulkhead is constructed of flat sheet and formed sections riveted and bolted together. The forward fuselage carries the basic body bending loads and supports the crew module and reacts the NLG loads. The fwd fuselage shell is composed of 2024 aluminum alloy skin stringer panels, frames, and bulkheads. The crew module is a welded 2219 aluminum alloy assembly supported at four points on the $X_{\circ} 576$ bulkhead, but is not structurally connected to the forward fuselage. The frames are sheet-metal formed parts riveted to the skin stringer panels, spaced 20-24 inches apart.

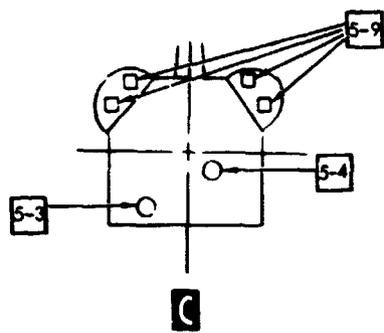
C
X_o 1307 BLKHD
LOOKING FWD

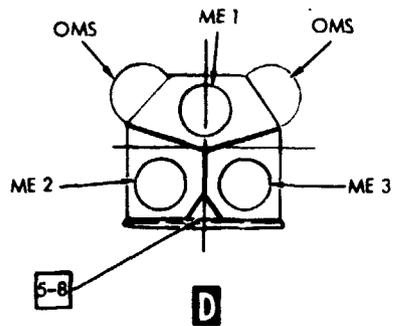
D
AFT HEAT SHIELD
LOOKING FWD

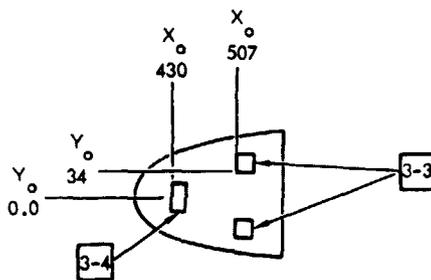
G
FLIGHT DECK FLOOR
LOOKING DOWN

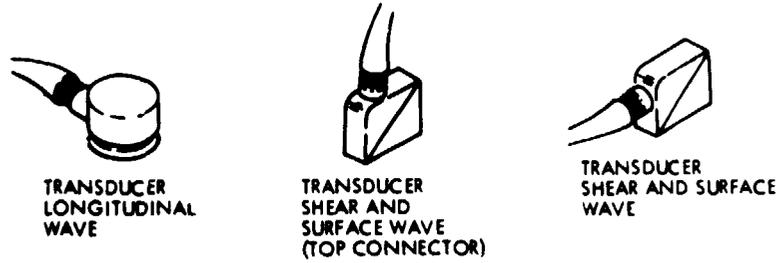
Ultrasonic Transducer Symbols

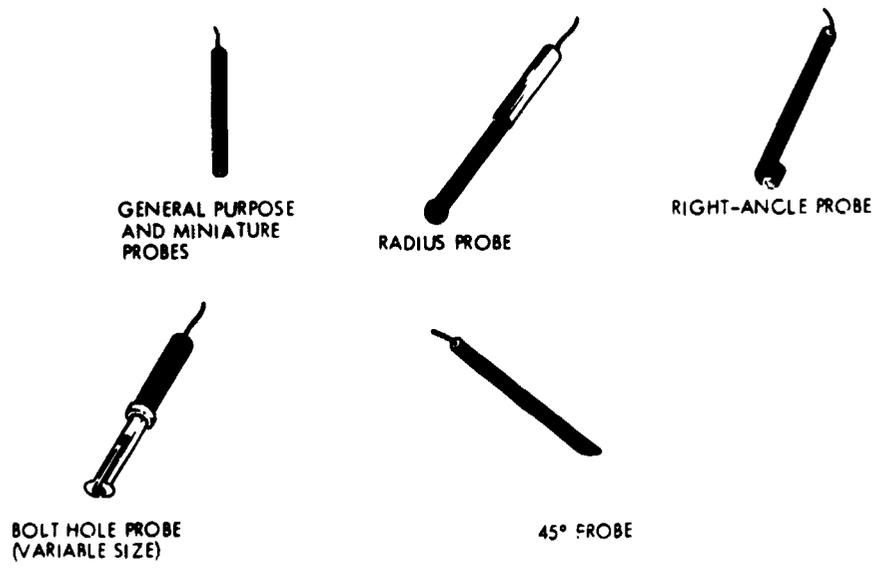
Eddy Current Probe Symbols

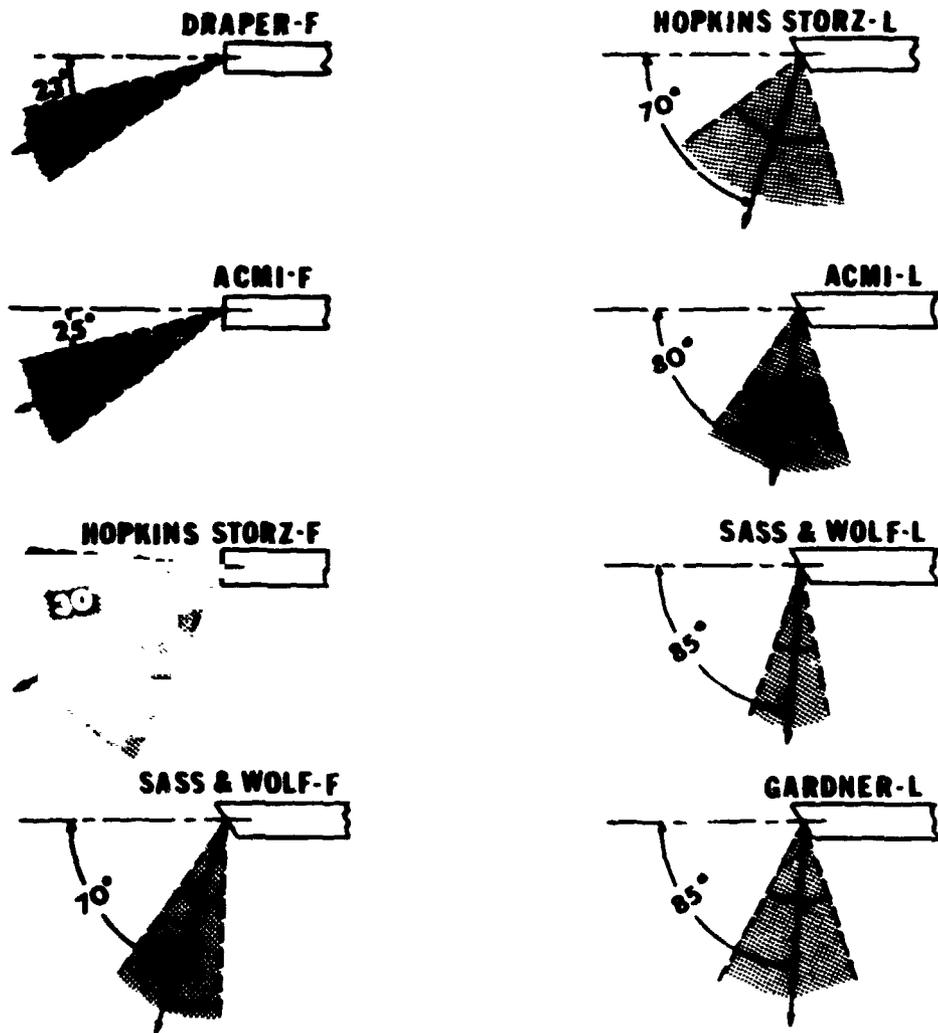
Figure 1-8. Direction and Field of View for Several Types of Borescopes

LATERAL	FOROBLIQUE	FORWARD
ACMI	52°	30°	--
Sass and Wolf	30	35	--
Gardner	47	47	--
Draper	--	--	23
Hopkins-Storz	70	70	--

A. Borescopes (Refer to Figures 1-7 and 1-8.)

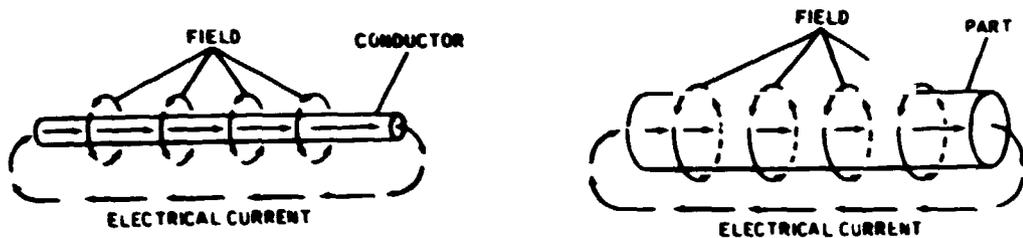
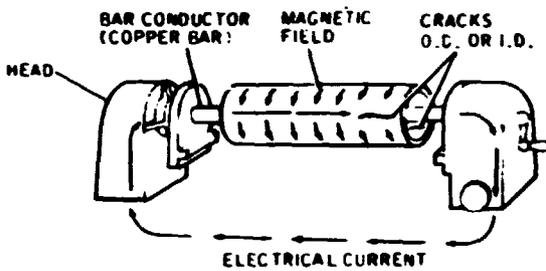
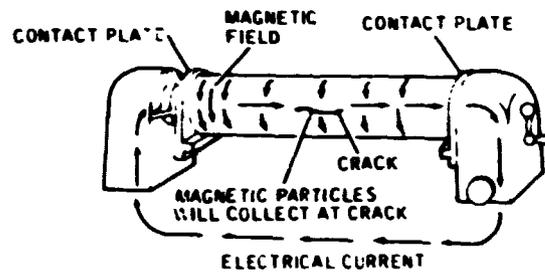
Figure 1-11. Magnetic Particle NDE Circular Magnetization Technique

EXAMPLES OF CIRCULAR MAGNETIC FIELD SURROUNDING A CONDUCTOR CARRYING AN ELECTRICAL CURRENT

CIRCULAR MAGNETISM USED TO DETECT LONGITUDINAL CRACK IN HOLLOW TEST PART

CIRCULAR MAGNETISM USED TO DETECT LONGITUDINAL CRACK IN SOLID TEST PART

Circular Magnetization - Circular magnetization occurs when the current is passed directly through the part, thus creating concentric circles of magnetic lines about the axis of the part. This technique is depicted in the sketches of Figure 1-11. Circular fields about a central conductor electrode are used to inspect the inside of cylindrical holes or cavities, such as a large bolt hole in a lug. The electrode should have nearly the same diameter as the hole or cavity being inspected or, if it is considerably smaller, should be rotated about the inside surface for complete coverage. Cracks oriented parallel to the hole axis in the walls of the hole can be detected with circular fields.

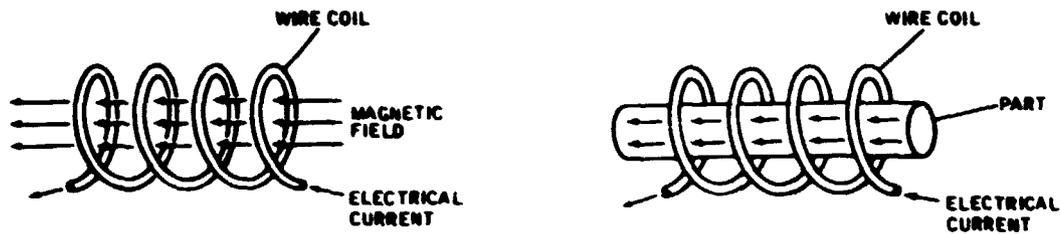
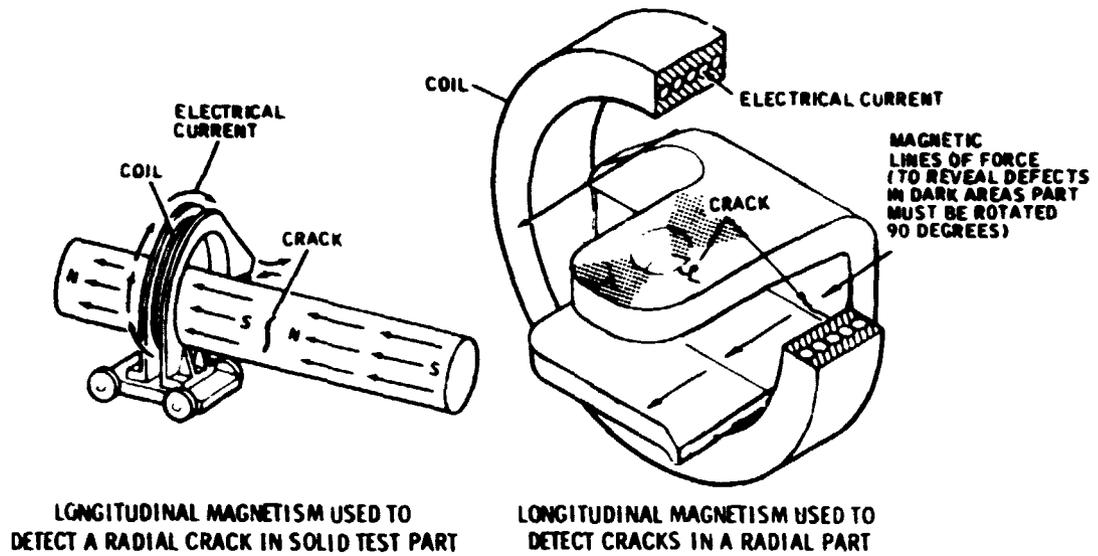
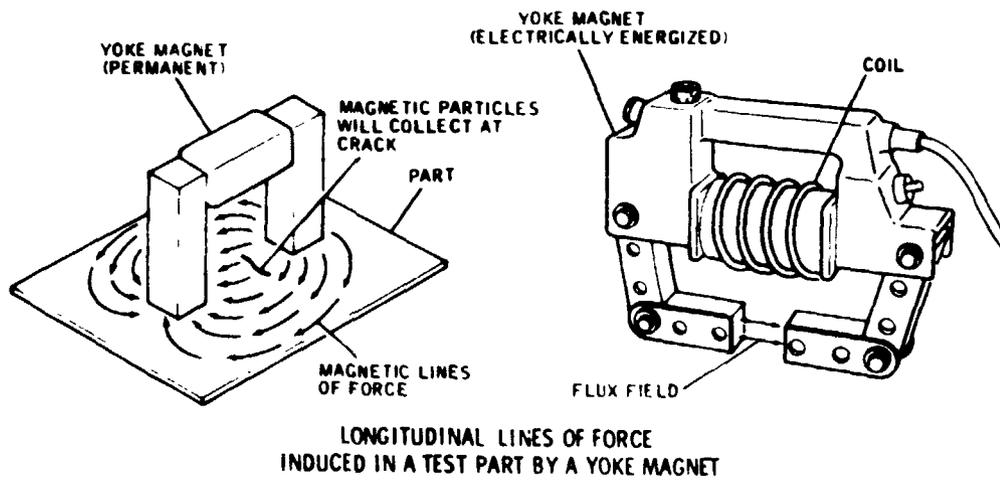
Figure 1-12. Magnetic Particle NDE Longitudinal Magnetization Technique

EXAMPLES OF LONGITUDINAL MAGNETIC FIELD AS PRODUCED BY A COIL

LONGITUDINAL MAGNETISM USED TO DETECT A RADIAL CRACK IN SOLID TEST PART

LONGITUDINAL MAGNETISM USED TO DETECT CRACKS IN A RADIAL PART

LONGITUDINAL LINES OF FORCE INDUCED IN A TEST PART BY A YOKE MAGNET

Longitudinal Magnetization - Longitudinal lines of magnetic field are produced near the center of a coil through which a current is passing. A ferrous rod placed along the inside diameter of the coil will then have magnetic lines of force induced along paths generally parallel to its axis as shown in Figure 1-12. Cracks oriented along the circumference of the rod perpendicular to its axis can then be detected after applying the magnetic particle solution.

Parker Probe (Portable Hand Probe) Operating Instructions - The Parker Probe, illustrated by the yoke magnet shown in Figure 1-12, can only be operated on 105- to 125-volt alternating current, 60-cycle, single-phase, power supply. The maximum duty cycle ratio is two minutes "on",

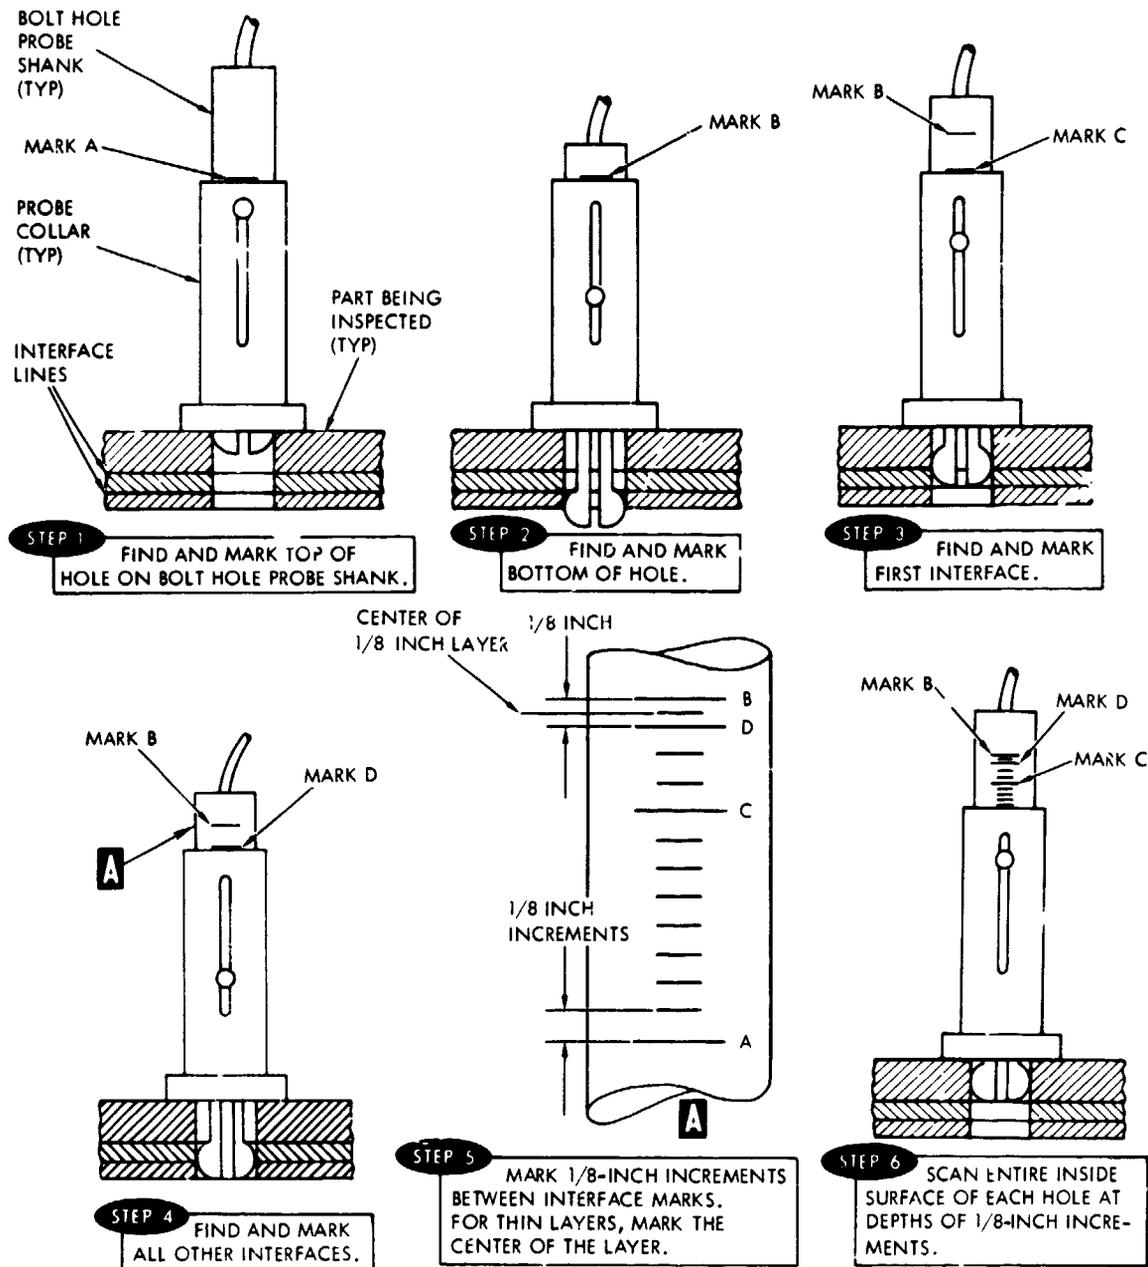
1. THIS PROCEDURE IS TO BE USED ONLY FOR INSPECTING HOLES WHERE ALL LAYERS OF MATERIAL ARE THE SAME BASIC MATERIAL. WHERE DISSIMILAR METALS COMPRISE A SINGLE BOLT HOLE, THE SCAN DEPTHS WILL BE SHOWN ON THE SPECIFIC PROCEDURE.
2. INTERFACES CAN BE DETECTED BY MOVING THE PROBE THROUGH THE HOLE AND NOTING WHERE THE METER NEEDLE MOVES OFF-SCALE. THE POINT AT WHICH THE METER NEEDLE MOVEMENT CHANGES DIRECTION IS THE DEPTH INTO THE HOLE WHERE THE INTERFACE IS LOCATED.

- a. Select and calibrate the appropriate bolt hole probe and instrument for the inspection.
- b. Determine the overall depth of the hole by inserting the probe into the hole to a depth where the meter indicator first comes to rest. Then place the probe holder on the part being inspected and mark where it stops on the shank of the bolt hole probe. Then move the probe through the bolt hole until the meter indicates that the probe coil has been moved completely out of the bolt hole. Again place the probe holder on the part and mark where it stops on the shank of the bolt hole probe.

- c. Move the probe back out of the bolt hole to the location where the meter indicator first came to rest and then advance the probe into the hole until the meter indicates that an interface between two of the mating parts has been reached. The meter indication will be the same for an interface and a crack. To be certain the meter deflection is not indicating a crack, move the probe to the center of the interface and adjust the meter needle to mid-scale. Then scan around the hole at that depth. A steady meter indicates an interface while deviation of the meter indicates a crack. The precise location of the interface can be found by moving the probe back and forth across the interface until the depth at which the meter

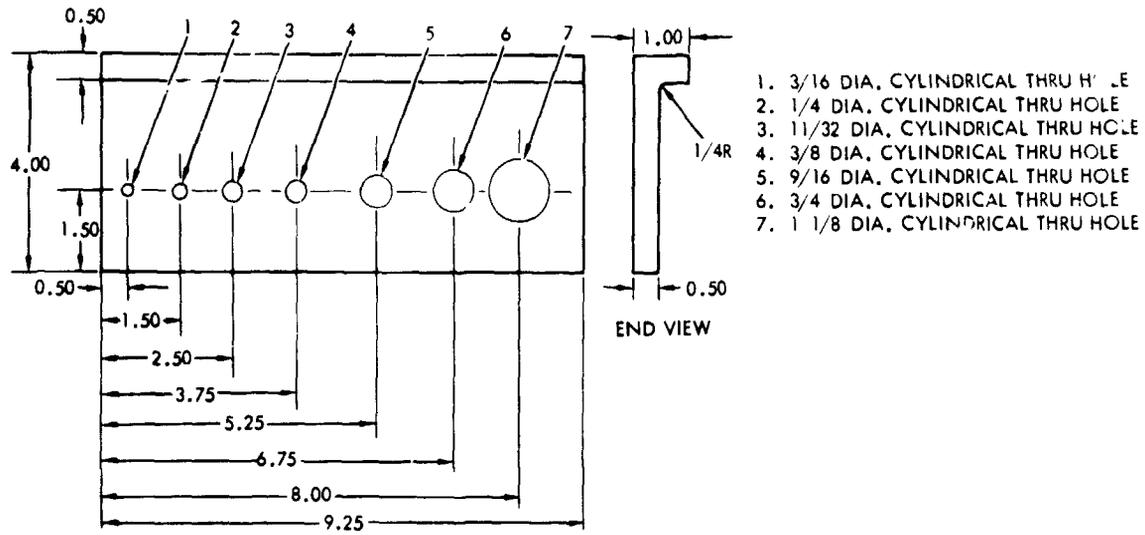
1. 3/16 DIA. CYLINDRICAL THRU HOLE
2. 1/4 DIA. CYLINDRICAL THRU HOLE
3. 11/32 DIA. CYLINDRICAL THRU HOLE
4. 3/8 DIA. CYLINDRICAL THRU HOLE
5. 9/16 DIA. CYLINDRICAL THRU HOLE
6. 3/4 DIA. CYLINDRICAL THRU HOLE
7. 1 1/8 DIA. CYLINDRICAL THRU HOLE

END VIEW

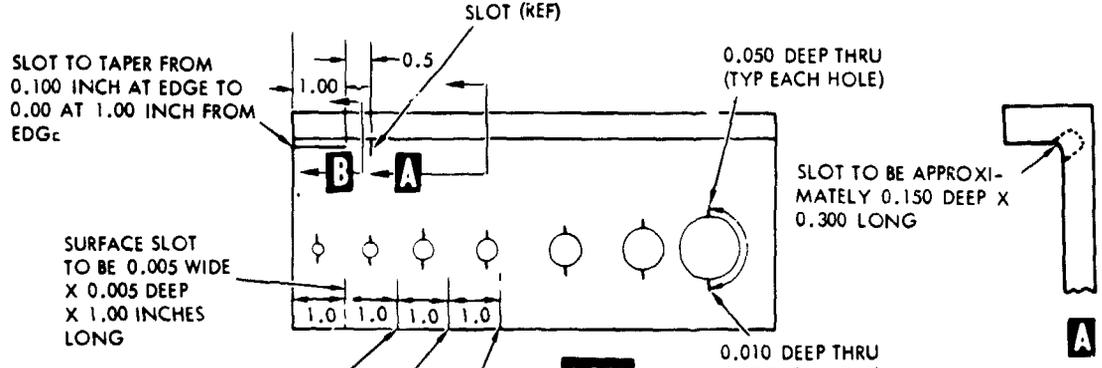
SLOT TO TAPER FROM 0.100 INCH AT EDGE TO 0.00 AT 1.00 INCH FROM EDGE

SURFACE SLOT TO BE 0.005 WIDE X 0.005 DEEP X 1.00 INCHES LONG

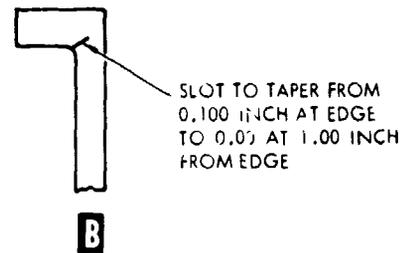
SLOT TO TAPER FROM 0.100 INCH AT EDGE TO 0.00 AT 1.00 INCH FROM EDGE

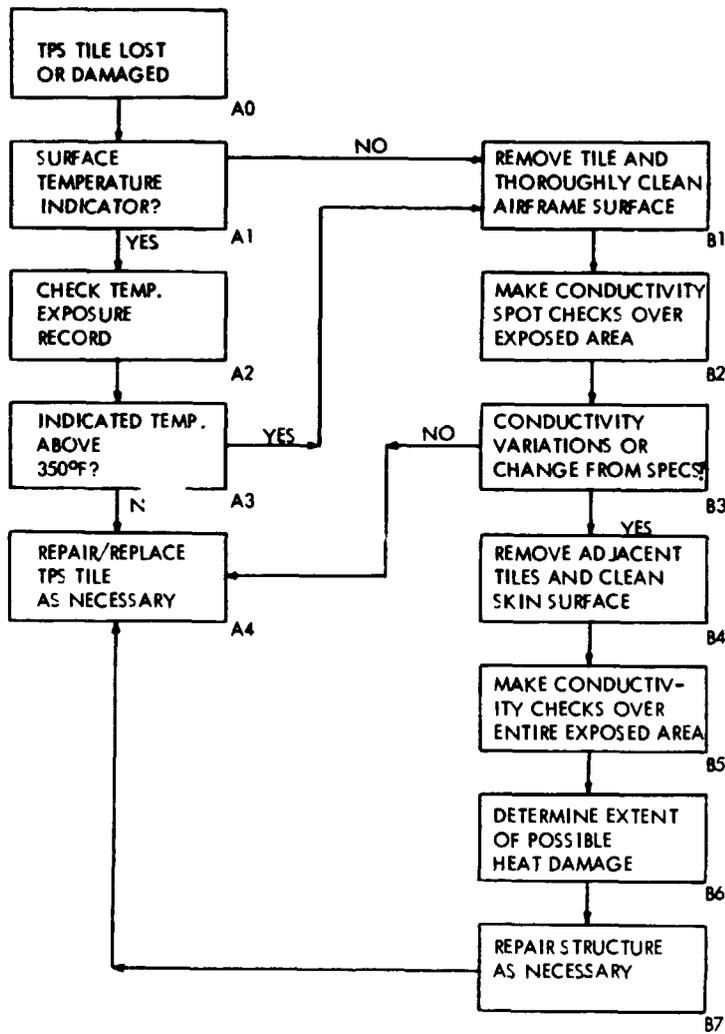
Figure 1-16. Procedure for Assessment of Heat Damage by Eddy Current Conductivity

ORBITER HEAT DAMAGE ASSESSMENT PROCEDURE

This procedure, outlined in flow-diagram form in Figure 1-16, is to be used when a TPS tile (LI-900) is lost or damaged during the orbiter entry phase or deorbit or when the integrity of the TPS surface coating has been (destroyed) or

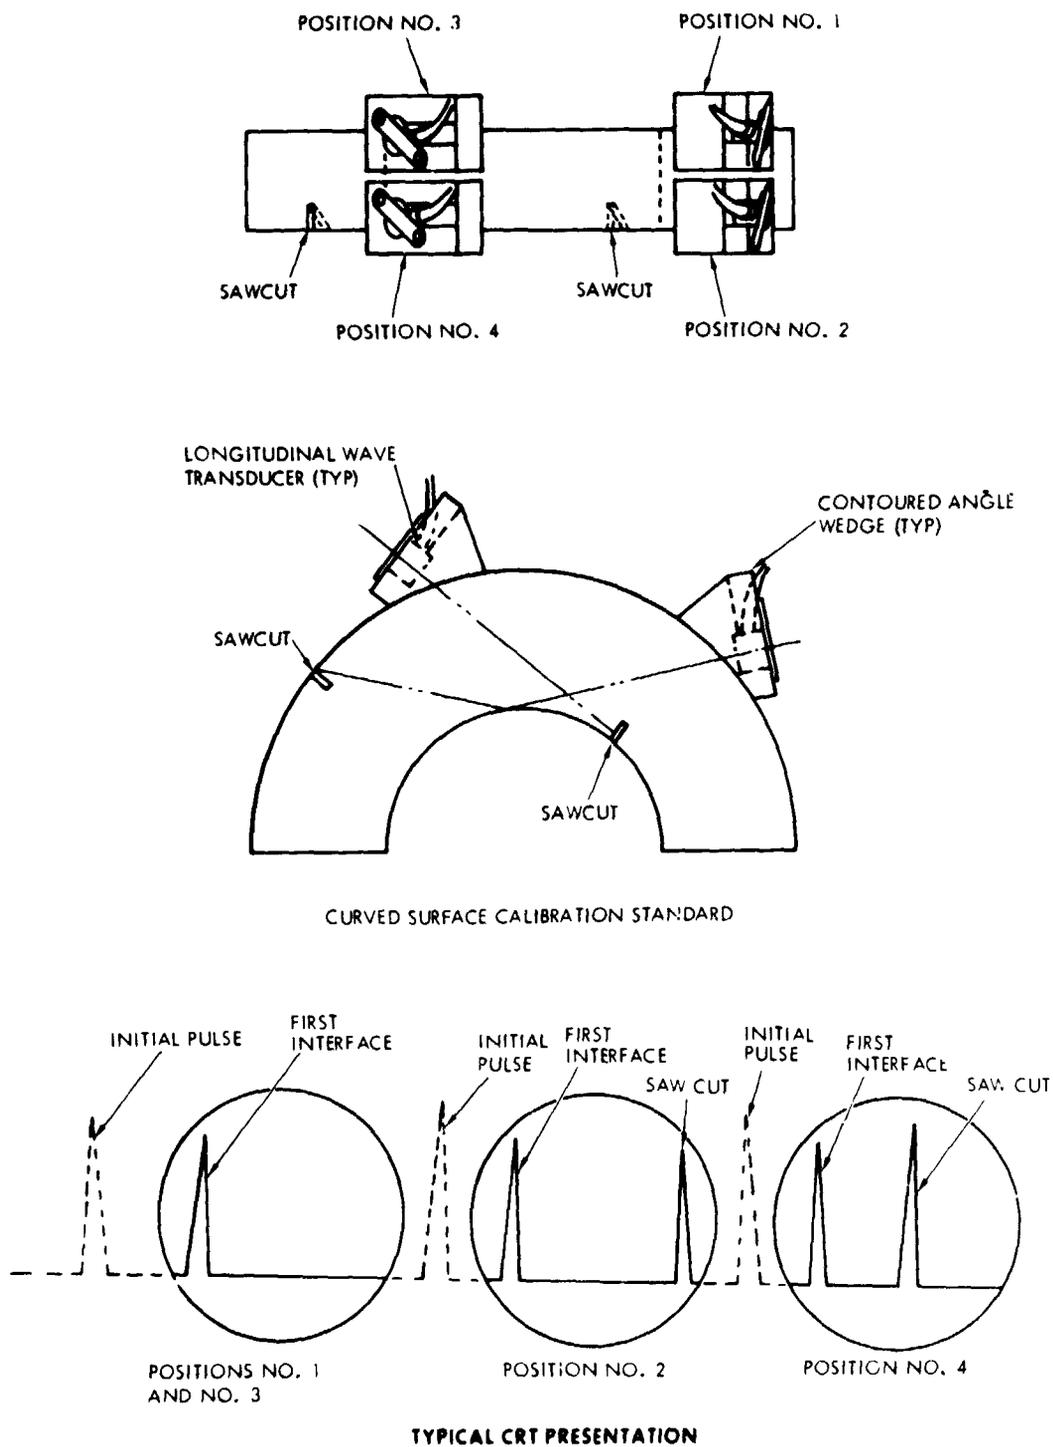
Figure 1-21. Initial Shear Wave Calibration - Lug Standard

INITIAL SHEAR WAVE CALIBRATION

- B. Initial Shear Wave Pulse Echo Technique - Lug Standard - A typical instrument calibration procedure relating to a pulse-echo shear wave test mode is given below as used on a clevis lug to inspect the bolt hole. The Sperry UM 715 Reflectoscope has been selected as the test instrument. Figure 1-21 illustrates the technique, calibration standard, and CRT presentation for this technique.

- (1) Apply couplant and couple transducer and wedge in either position No. 1 or No. 3 (Figure 1-21). Adjust sweep delay to position the first interface near the left side of the scope.

- (2) Apply couplant and position transducer and angle wedge in position No. 2 (Figure 1-21) to obtain signal from simulated defect and maximize signal. If signal is not present a slight adjustment of the following controls may be required to achieve the desired CRT indication as illustrated or in appropriate procedure:

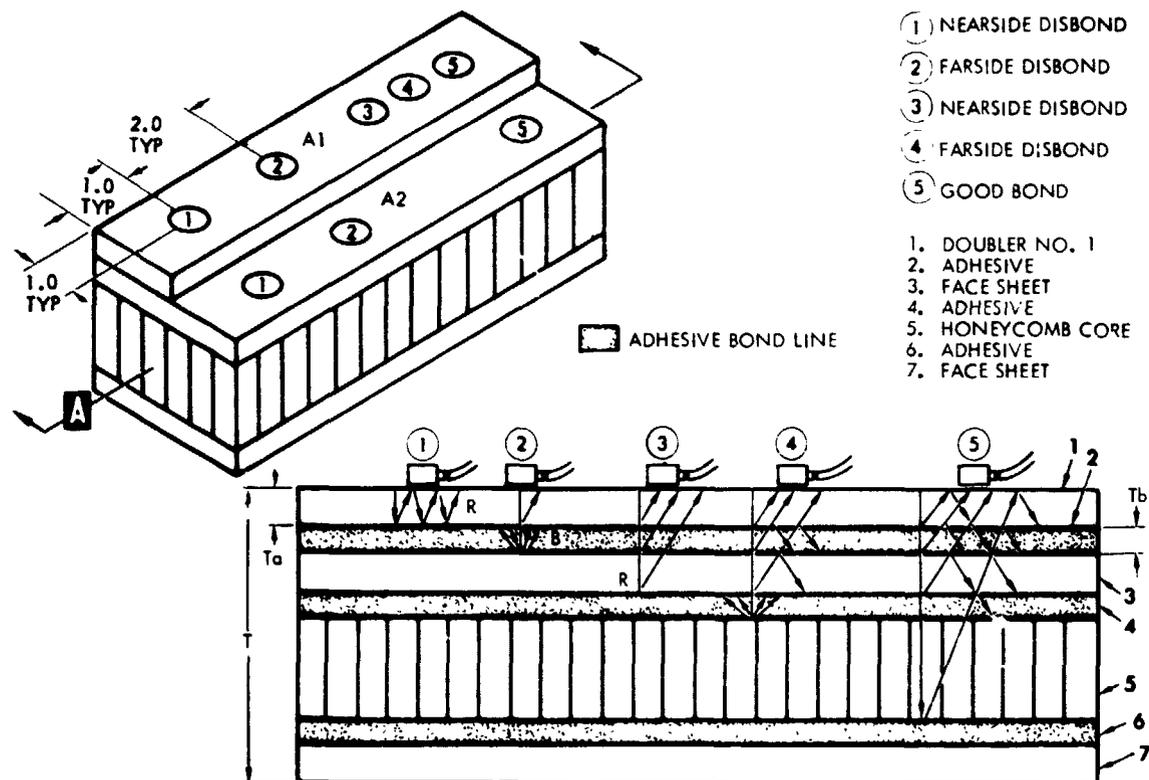
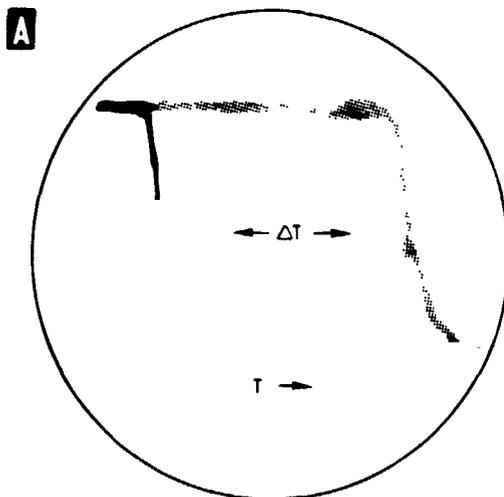
Figure 1-23. Principles of Ultrasonic Instrument Calibration - Honeycomb Bonded Structures

COMPOSITE WITH INTERNAL DOUBLER AND THREE BOND LINES

TYPICAL CALIBRATION STANDARD

1. THE ULTRASONIC ENERGY REACTS AT ALL INTER-FACES RANGING FROM THE UPPER FACE SHEET/ADHESIVE THROUGH THE COMPOSITE. THE FACTORS WHICH AFFECT THE ENERGY ARE ATTENUATION (A), THICKNESS (T), SCATTERING (B), REFLECTION (R) AND DENSITY OF CORE (D).
2. T_a - THICKNESS ALUMINUM FACE SHEET.
3. T_b - THICKNESS - BONDLINE.
4. NEARSIDE DISBOND - A DISBOND LOCATED ON THE TRANSDUCER SIDE OF THE ADHESIVE, IN THE ADHESIVE AND FAYING SURFACE INTER-FACE.
5. FARSIDE DISBOND - A DISBOND LOCATED ON THE OPPOSITE SIDE OF THE ADHESIVE FROM THE TRANSDUCER, IN THE ADHESIVE AND FAYING SURFACE INTERFACE.
6. ADHESIVE BOND LINE - A LAYER OF ADHESIVE BETWEEN TWO FAYING SURFACES.
7. THIS EXAMPLE IS INSPECTING ONE SIDE ONLY.

THE QUANTITY OF RETURNING ULTRASONIC ENERGY IS DISPLAYED ON AN OSCILLOSCOPE. THE BASE LENGTH OF THE SIGNAL ON THE OSCILLOSCOPE IS INDICATIVE OF THE ULTRASONIC PULSE TRANSIT TIME IN THE PART AND THE RETURNING ENERGY.

Principles of Ultrasonic Instrument Calibration - Honeycomb - Figure 1-23 illustrates the standards and technique to be used in this procedure. Figure 1-24 illustrates typical CRT presentations of signals for various bond-line conditions.

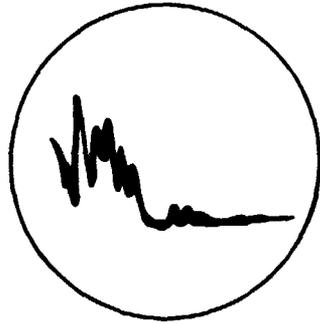
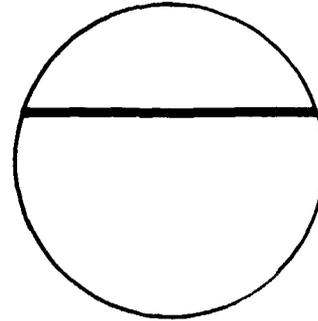
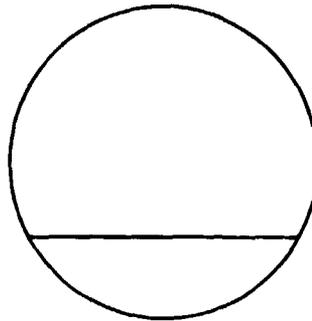
TYPICAL CRT PRESENTATION

VIEW "A" GOOD BOND

VIEW "B" NEAR SIDE DISBOND (1) AND (3) FOR 5.0 MHz TRANSDUCERS AND ION² MODULE

VIEW "C" FAR SIDE DISBOND (2) AND (4) USING ION MODULE
ALL DISBONDS (1), (2), (3) AND (4) USING IN MODULE

- c. When the specified "good" signal is obtained with the transducer, then the transducer is placed over the nearside disbond, i.e., a disbond between the adhesive and facesheet. A loss of signal pattern should be observed on the CRT; however, in some procedures where a 5 MHz transducer of sufficient power is used, a ringing pattern will indicate a nearside disbond.

- (2) The transducer is then placed over the far side disbond area. A complete loss of signal should be noted on the oscilloscope for all far-side disbonds in all procedures, and all disbonds when using a 1N pulser module.

- (3) View C of the figure in the typical CRT presentation illustrates a marked decrease in energy returning to the transducer over a farside disbond. This decrease is partially caused by the energy being scattered in the adhesive at a void between the adhesive and honeycomb core. A slight adjustment of the Reject control may be required to completely eliminate all signal noise on the base line. After this has been accomplished, recheck all above areas to verify the read-out.

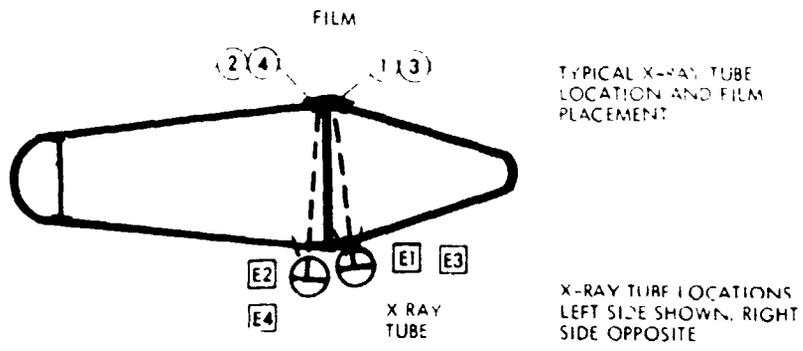
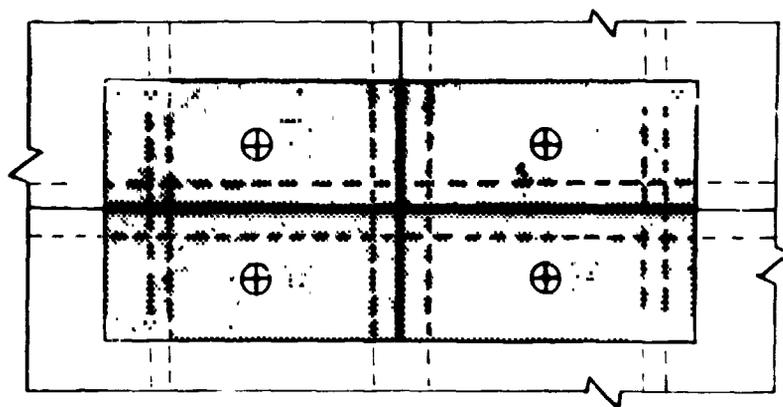
Figure 1-25. Example - X-Ray Radiography Application, Illustrating Symbols, Film Placement, and Data Table

RADIOGRAPHIC INSPECTION DATA							
EXPOSURE NUMBER	KV	MA	FFD (INCHES)	TIME (SEC)	FILM		REMARKS
					TYPE	SIZE	
E1							EXPOSE 1
E2							EXPOSE 2
E3							EXPOSE 3
E4							EXPOSE 4

Description - X-ray inspection is used to show internal and external structural details of all types of parts and material. This method is used for the inspection of airframe structure for defects otherwise inaccessible for other methods of non-destructive inspection, or to verify conditions indicated by another method. A typical X-ray application of airframe structure is shown in Figure 1-25.

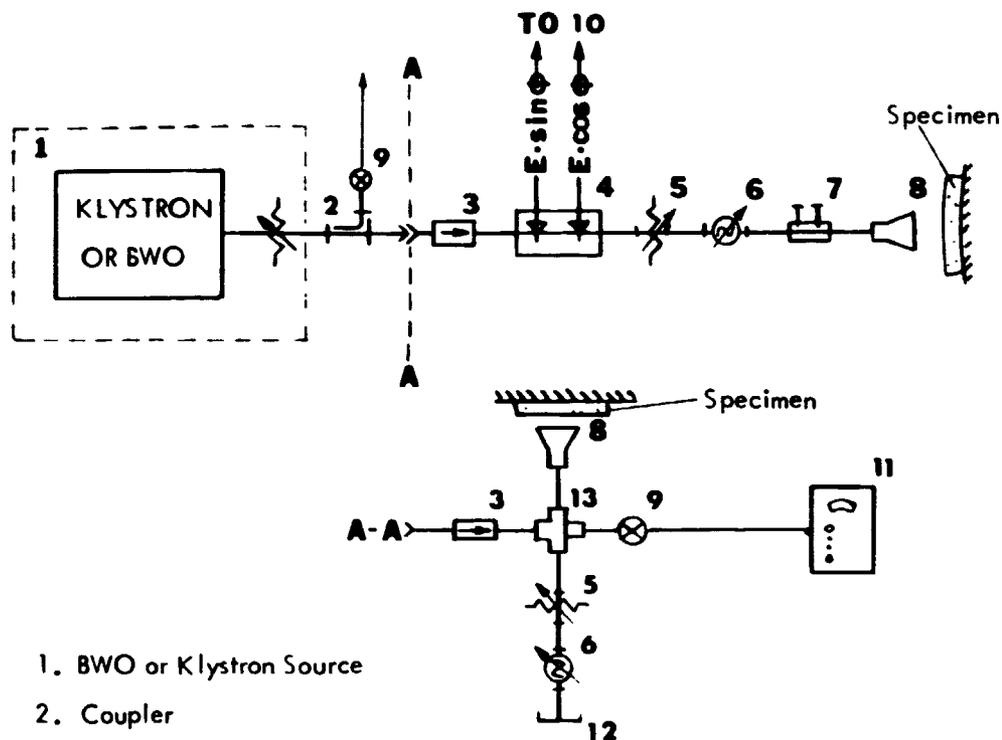
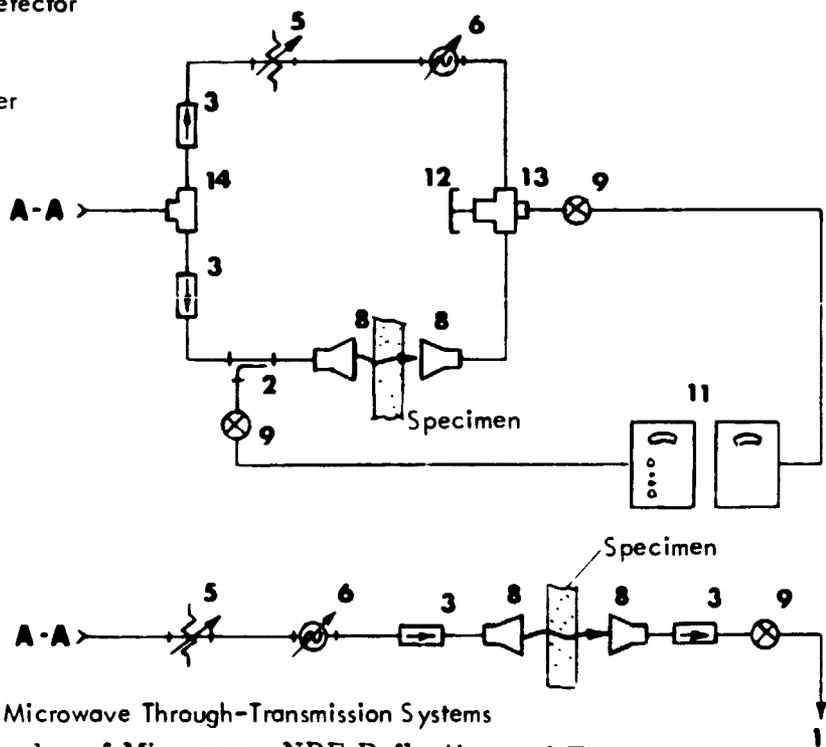
Figure 1-29. Examples of Microwave NDE Reflection and Through-Transmission Systems

Microwave Reflectometer Systems

1. BWO or Klystron Source
2. Coupler
3. Isolator
4. Impedance Plotter Detector
5. Variable Attenuator
6. Variable Phase Shifter
7. Tuner
8. Waveguide Antenna
9. Crystal Detector
10. X-Y or Polar Plotter
11. Power or SWR Meter
12. Tuneable Short
13. Hybrid (Magic) Tee
14. Waveguide Tee
15. Reflector

Microwave Through-Transmission Systems

The equipment can be arranged either as a reflectometer system or as a through-transmission system. With sufficient microwave waveguide components on hand any of the illustrated systems can be arranged. Adequate standards representing material, geometry, configuration (e.g., material on substrate) and defects must be available.

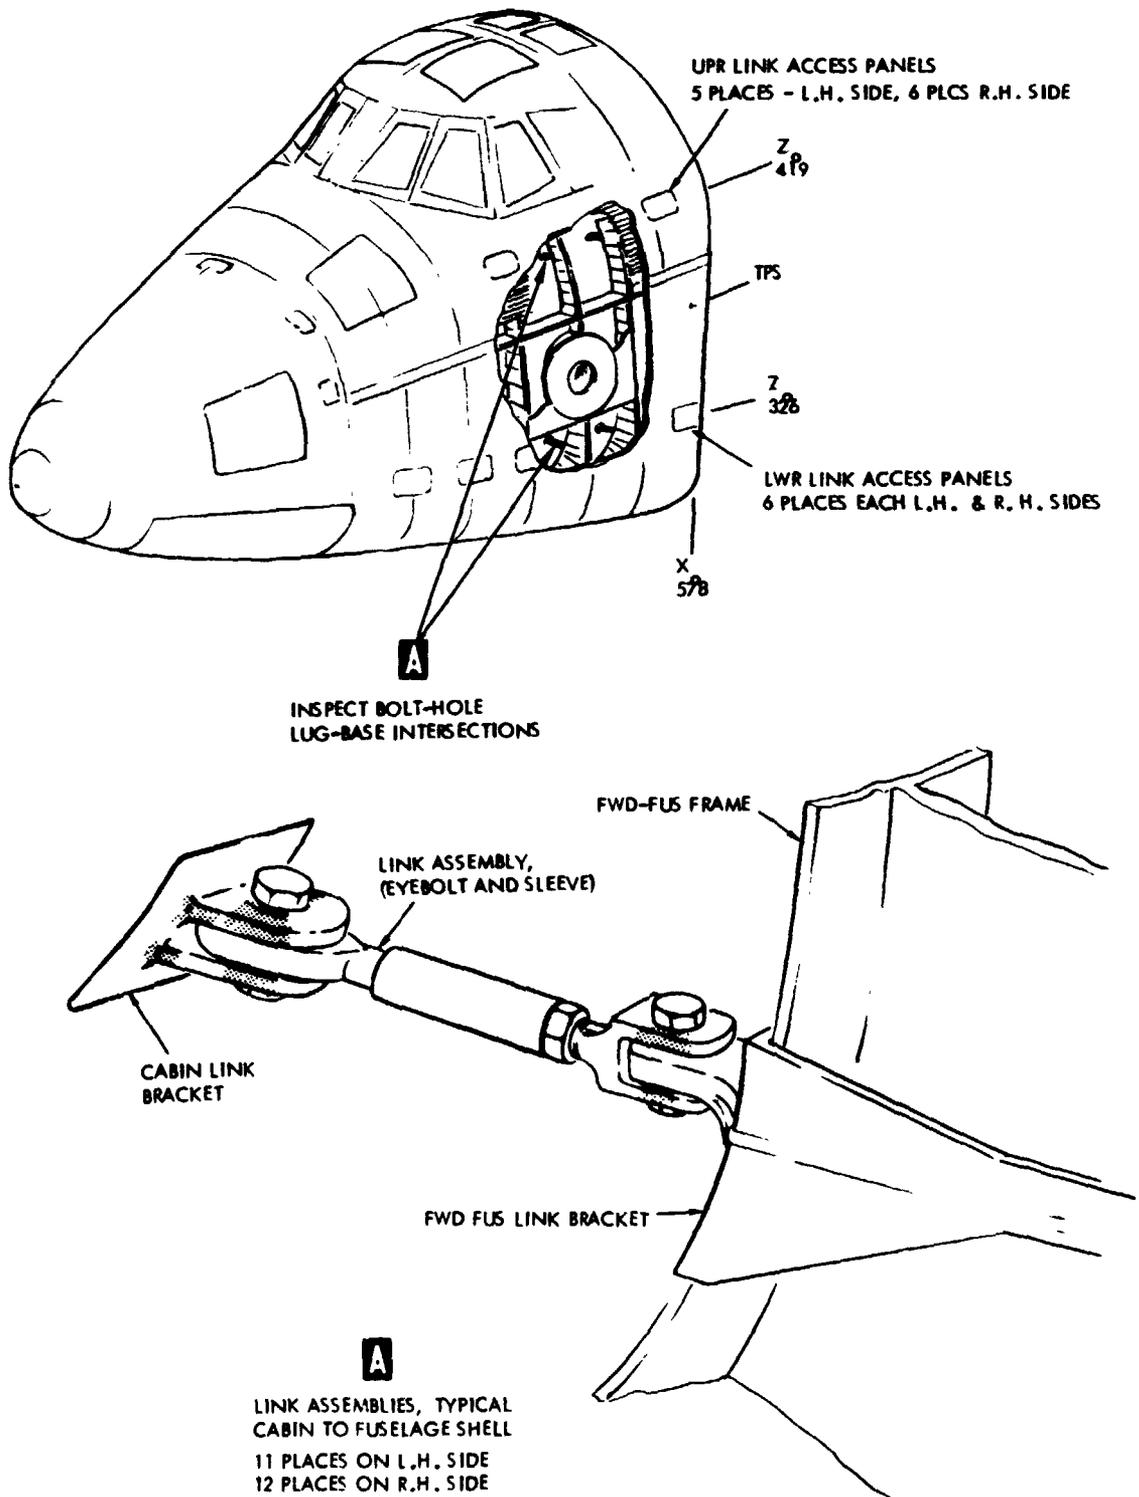
Figure 2-1. Cabin-Fuselage Shell Support Link and Bracket Assembly

NOTE: In the event that access is severely restricted, built-in ultrasonic or fiber optics may provide more appropriate inspection.

BACKUP: Fluorescent penetrant of lugs after disassembly if necessary (see para. 1.5.2.1 Figure 1-9)

PROCEDURE NO. 2-101, Figure 2-1

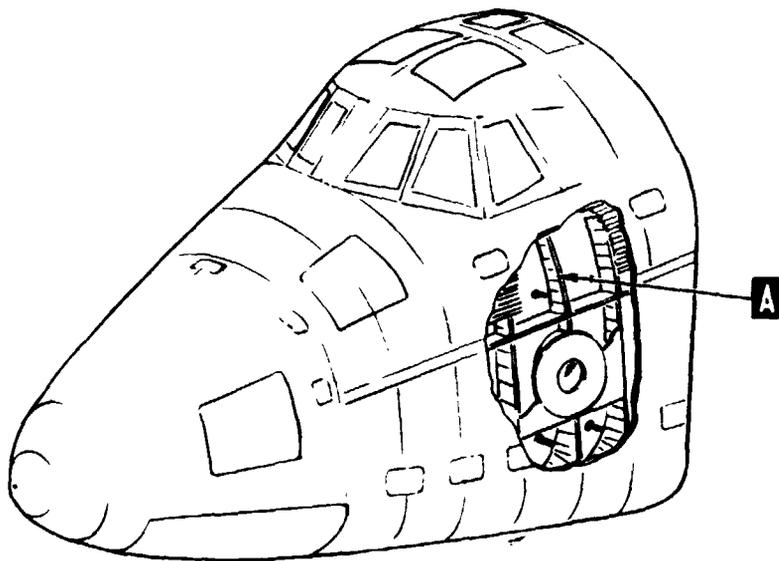
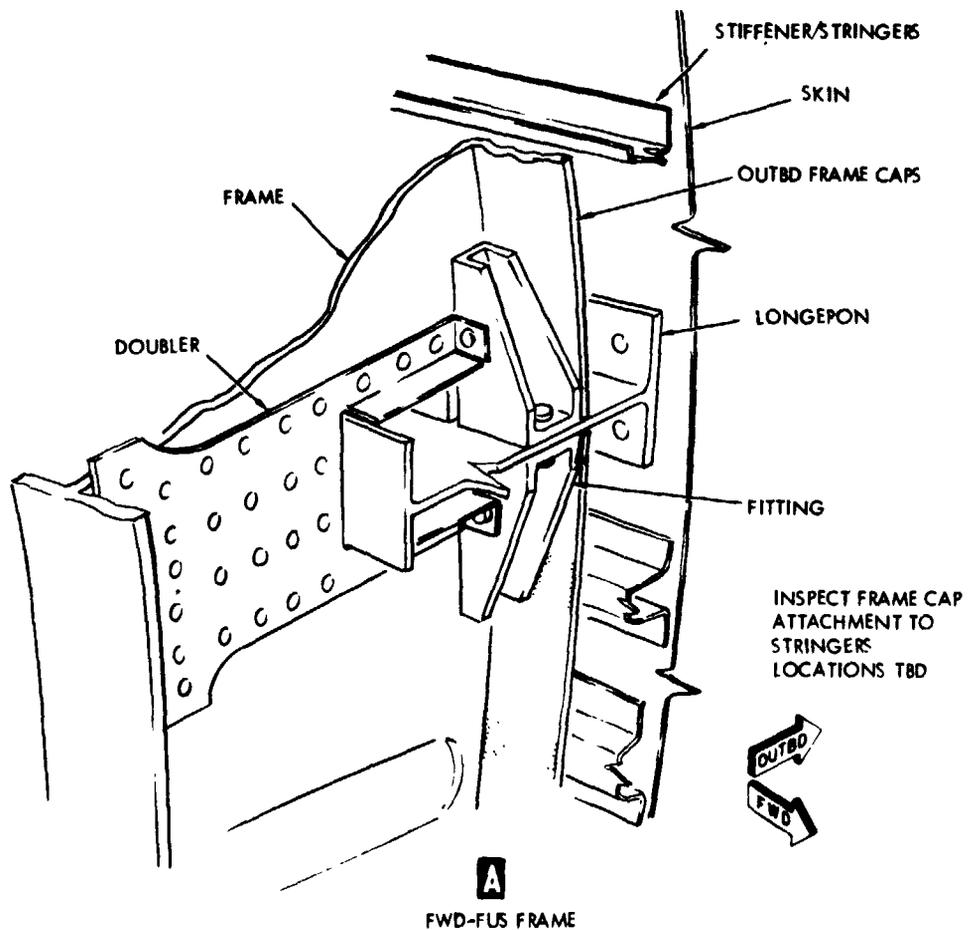
Figure 2-2. Forward Fuselage Frame Caps

DEFECTS: Horizontal cracks at fastener holes.

NDT TECHNIQUES: Primary: Radiography, fiber optics (see paragraph 1.5.6.2 and 1.5.1.3, respectively).

Backup: fiber optics (for radiography) (see para. 1.5.1.3).

PROCEDURE NO. 2-102, Figure 2-2

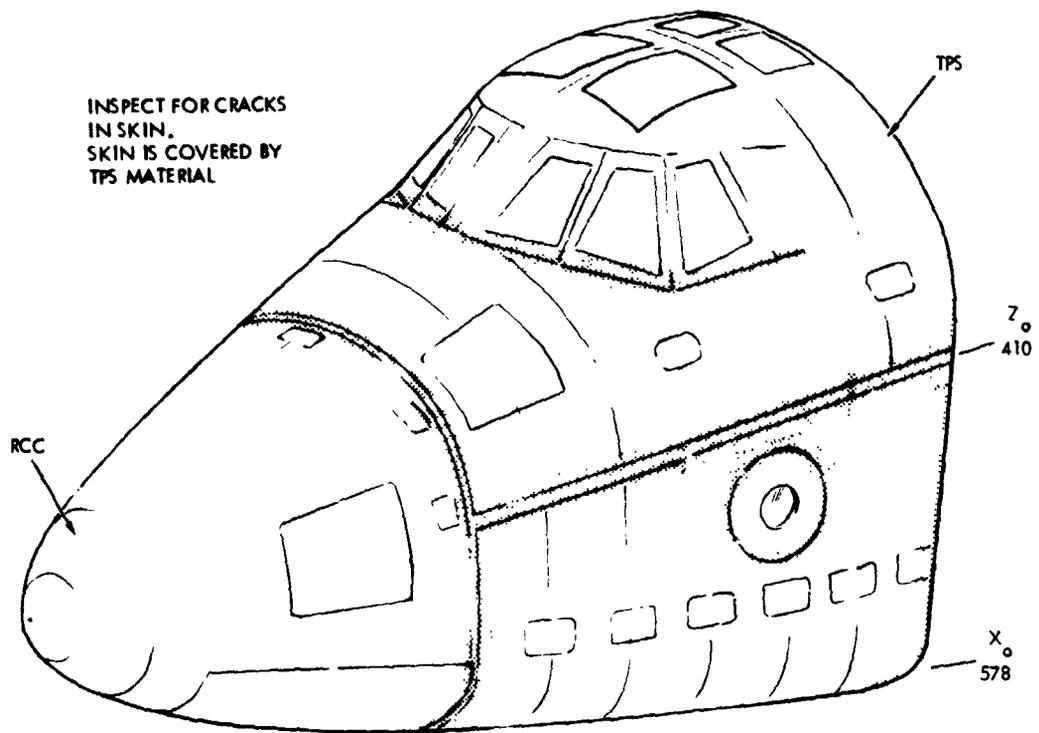
Figure 2-3. Forward Fuselage Skins

NDT TECHNIQUES: Primary: Radiographic or optical borescope (see paragraphs 1.5.6.2 or 1.5.1.3, respectively).

Backup: Eddy Current (see paragraph 1.5.4.4).

FWD FUS SHELL, SKIN PANEL SPLICES

PROCEDURE NO. 2-103, Figure 2-3

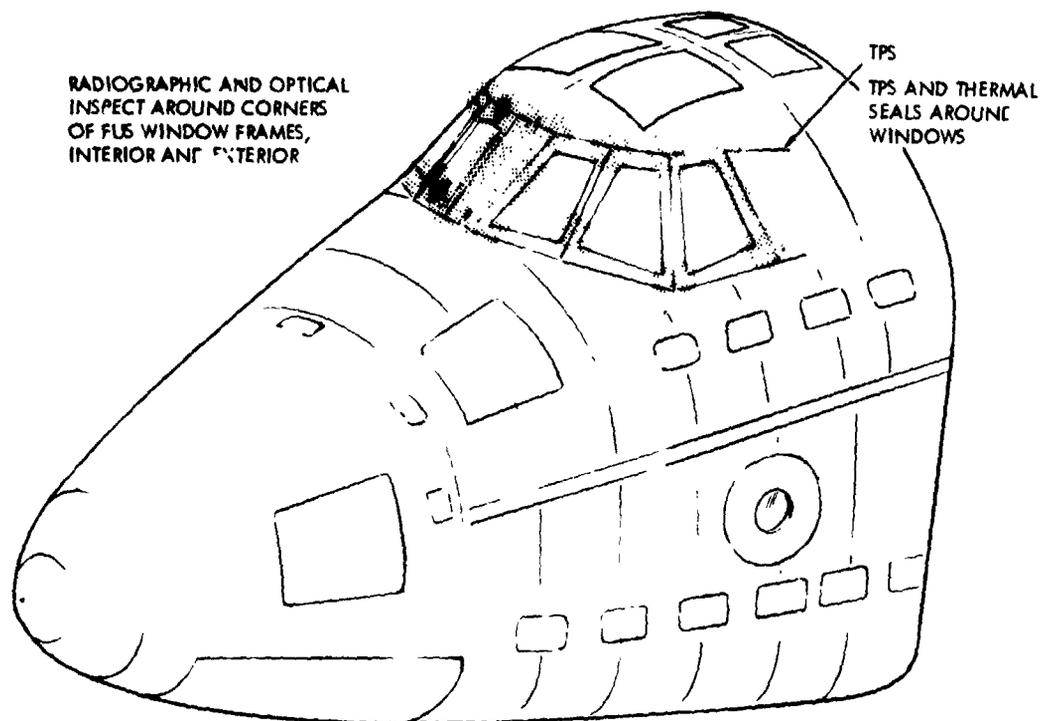
NDT TECHNIQUES: Primary: Optical or X-ray (see paragraphs 1.5.1.3 or 1.5.6.2, respectively).

RADIOGRAPHIC AND OPTICAL
INSPECT AROUND CORNERS
OF FUS WINDOW FRAMES,
INTERIOR AND EXTERIOR

TPS
TPS AND THERMAL
SEALS AROUND
WINDOWS
